EARTHEN HERITAGE DIAGNOSIS

French Embassy in Ghana | FSPI Sankofa

Sebastien Moriset, CRAterre | December 2021

CRAterre project code GHA031

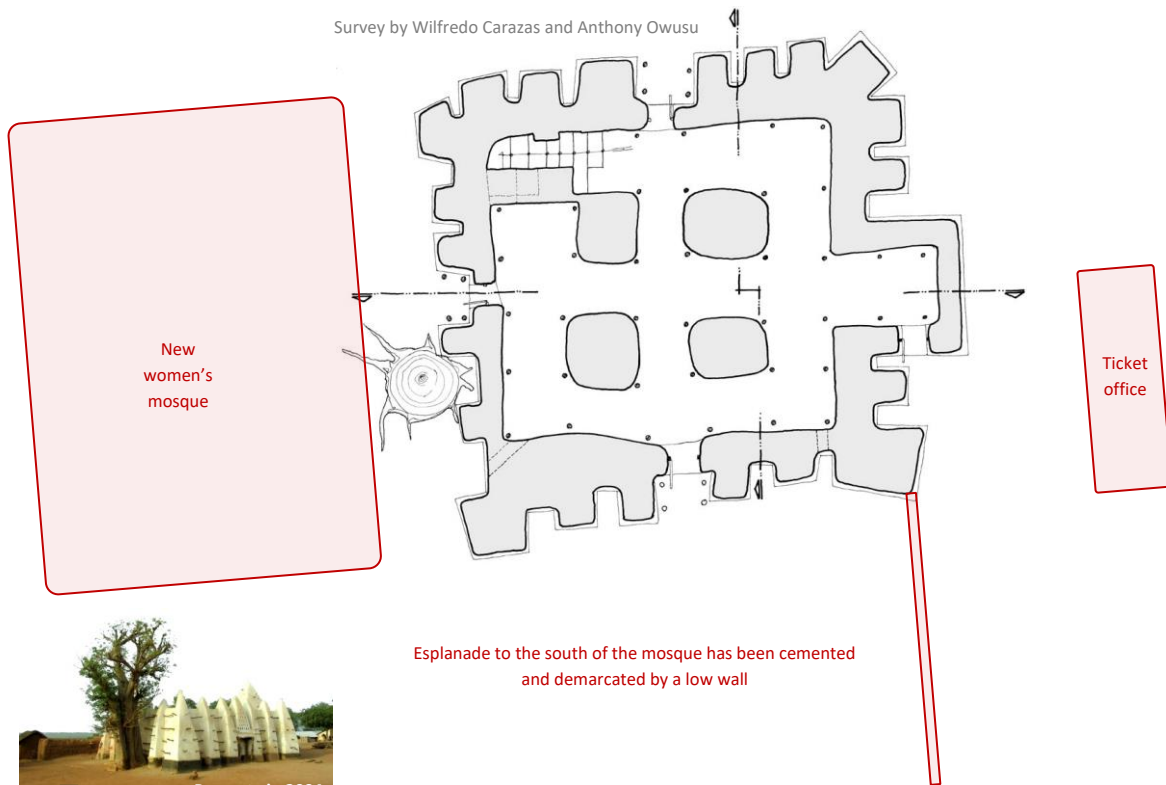
3.6. Larabanga

The village itself has changed dramatically. Fifteen years ago, all the houses were low with terraced roofs that served as a place to dry crops and to sleep during hot season. All these terraces have disappeared and been replaced by much higher pitched roofs. In this context, the mosque no longer has the importance it once had in the landscape, it is no longer a prominent feature.

A new women's mosque, toilets, a cemented esplanade, a boundary wall, a visitors' office, most village houses covered with corrugated iron roofs, etc. Larabanga is evolving very quickly.

- Work with the community on a management plan
- Demolish the cement mosque and relocate it at least 10 meters away from the old mosque

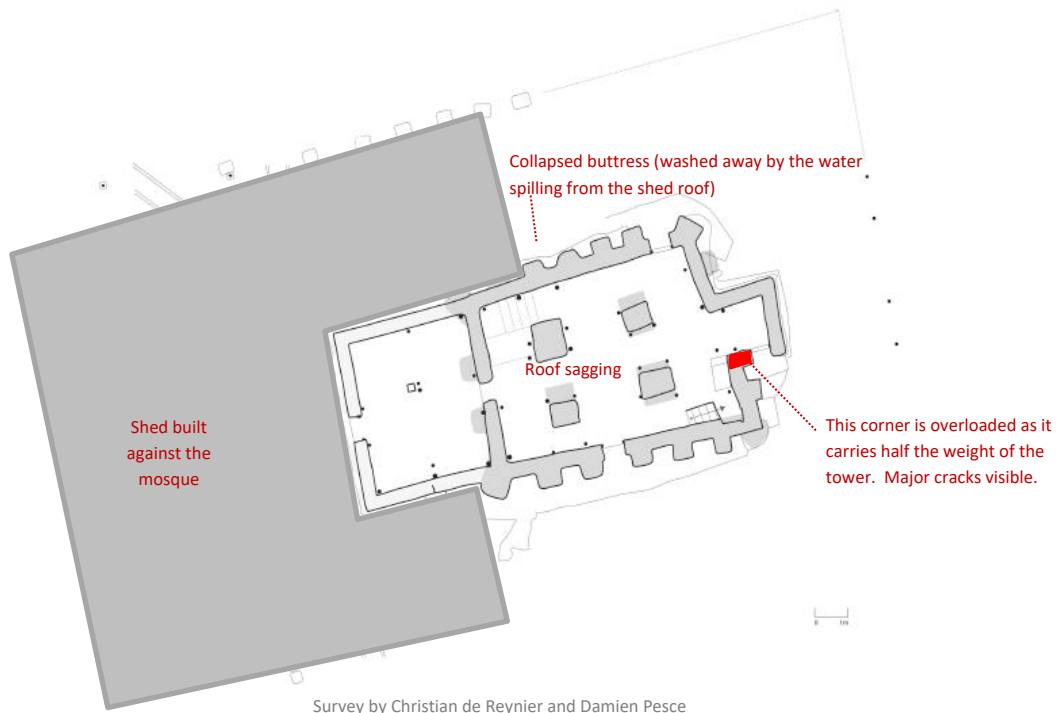
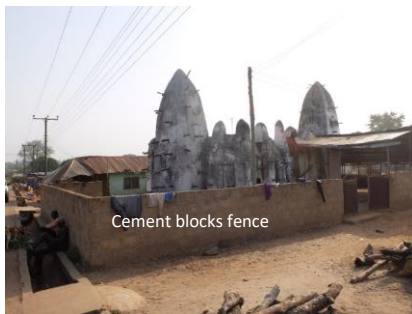
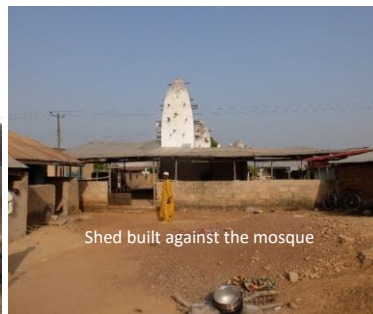
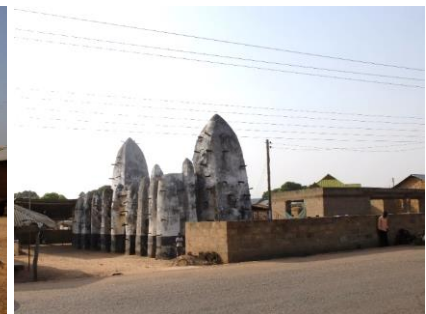
3.7. Maluwe

The mosque is in a worrying state. It is very wet due to the thick concrete plaster. The wood is badly deteriorated. The roof beams are in bad state and the roof slab is sagging in different places. A pinnacle has collapsed on the north side and multiple cracks are visible. The most worrying is the tower on the eastern side (Mirhab). The southwest corner of the tower is extremely fragile as it has to support half of the total weight of the tower. We suggest building a thick solid wall on the south side in place of the door to relieve the corner and prevent the mirhab from collapsing.

Worrying state of conservation of this mosque which needs major interventions, especially at the base of the mirhab.

- Install propping under the mihrab to reduce stresses on the south-west corner
- Replace the door on the southern base of the mihrab by a thick solid wall to spread the load of the tower more evenly on the base.

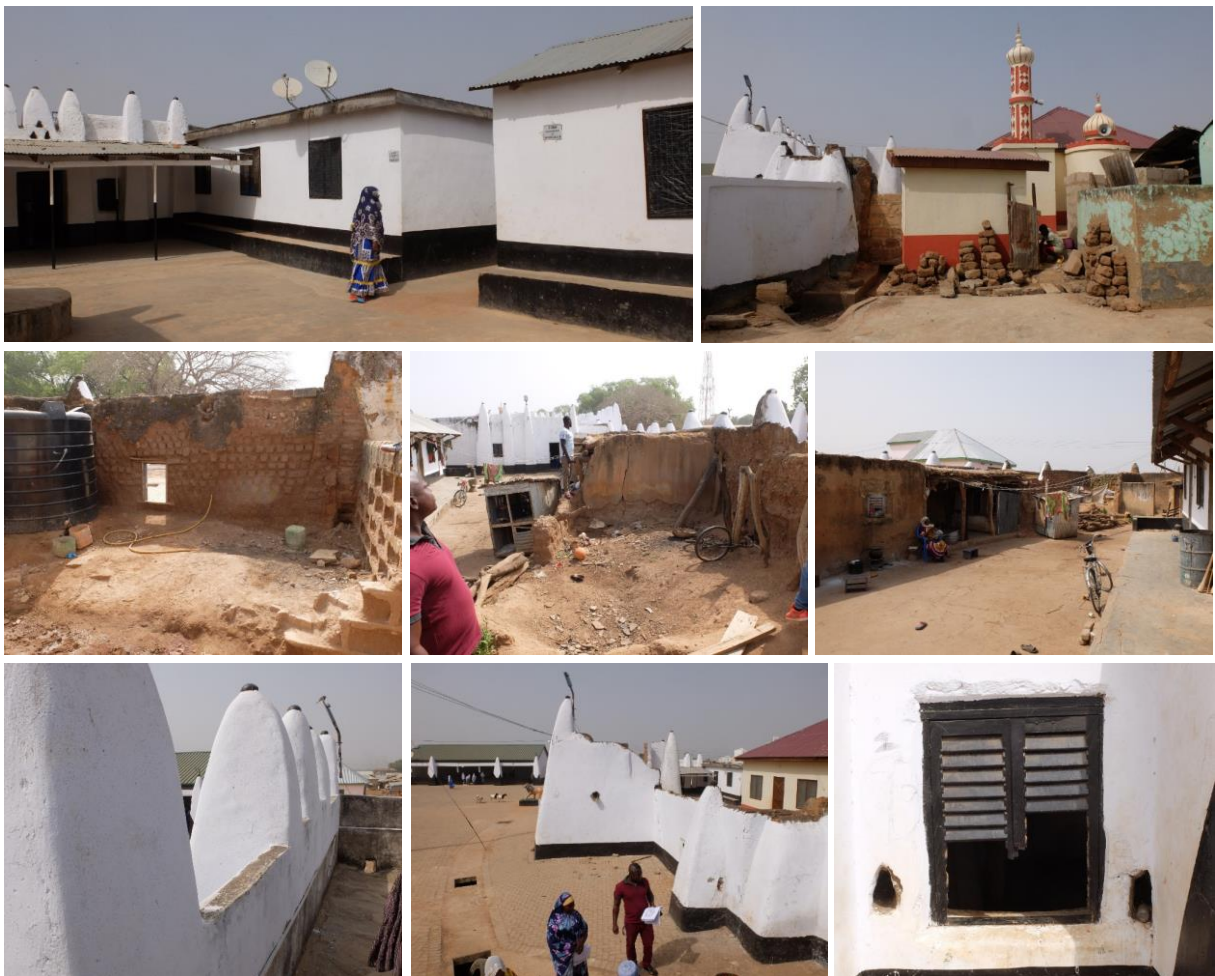
Unfortunately, there is hardly anything authentic left on the back of this façade.
